Church / Chapel Commercial Building Survey

Firstly, may we thank you for your instructions of xxx; we have now undertaken an independent Building Survey (formerly known as a Structural Survey) of the aforementioned property. This Survey was carried out on xxx.

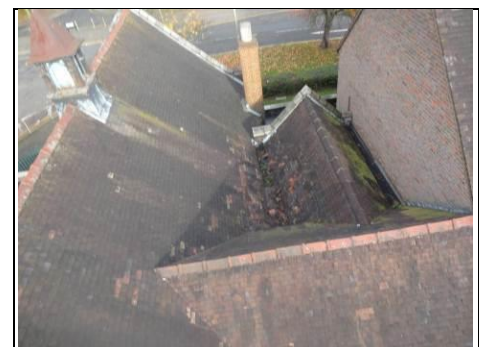
Roof over office area in poor condition
Aerial view – 360 photo

Our concern is beneath the tiles there are cross-battens, which in this case are deteriorating.

To ensure the roof has a long life you will need at some time to remove all the tiles, clear the debris from the cross-battens and repair and replace tiles as necessary. It may be that this debris is only to the lower parts of the cross-batten areas.

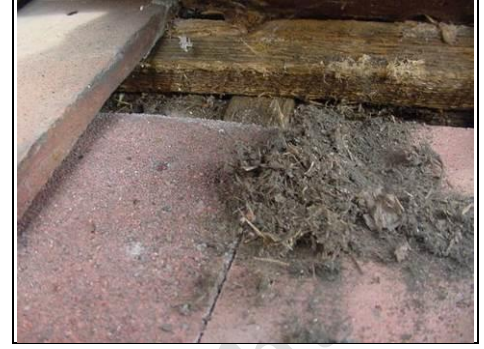
There is a substantial amount of debris beneath the tiles. From what we can see this is acting like blotting paper, causing the cross-battens to have accelerated rot and this needs clearing.

Soft rot occurring to cross-battens

It is likely that at the very least you will need to remove all the tiles, clear the debris from the cross-battens and repair and replace tiles as necessary.

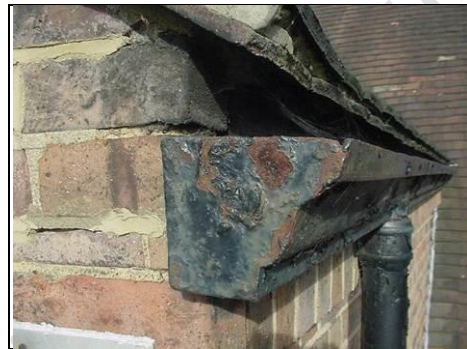
Rusting Ogee gutter

They are in cast iron and have not been maintained, which is particularly bad news with regard to ogee guttering as they tend to rust at the back.

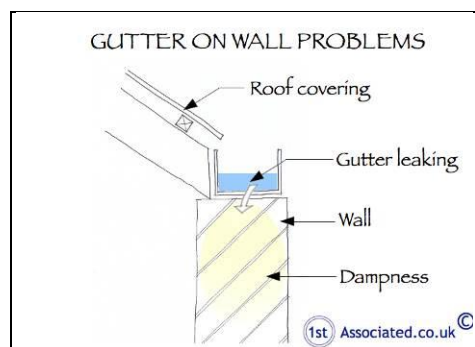
The second problem is the gutters are sit on gutters in many cases, meaning they sit on the walls, or partly on the walls, so that any leaks coming from them causes dampness to get into the wall structure and we can indeed see dampness getting in which we believe has caused the cornice to come away to the front right side of the main church area (it is likely to be other things such as blocked gutters from leaves etc). We were advised this happened about three years ago but we there is still high levels of dampness in this area.

Sit on gutters

ACTION REQUIRED: A high level inspection is required of the gutters to check they are sit on gutters. If they are sit on gutters then a programme of repairs and renewal of the gutters is recommended. It may even be necessary to put lead (or some sort of waterproof layer) underneath the sit on gutters depending upon how it is detailed.

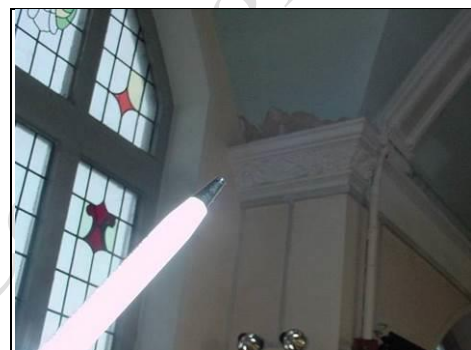
Leak from sit on gutters partly responsible for the coving coming down internally

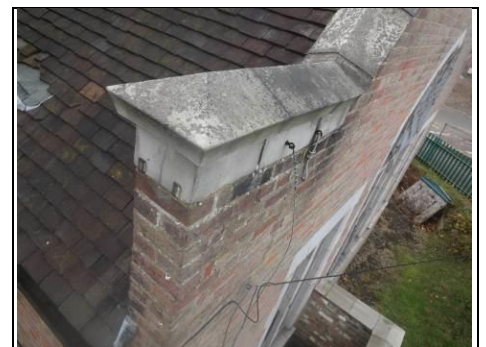
Repairs visible to coping stones

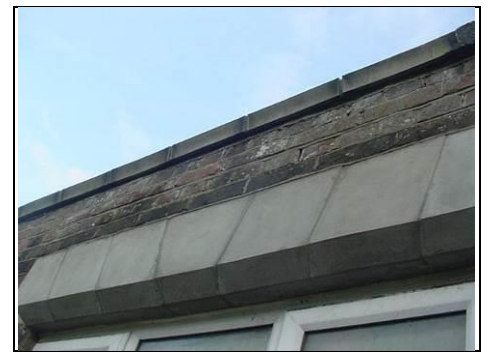
Cement coming out to wall below due to the rear parapet wall leaking

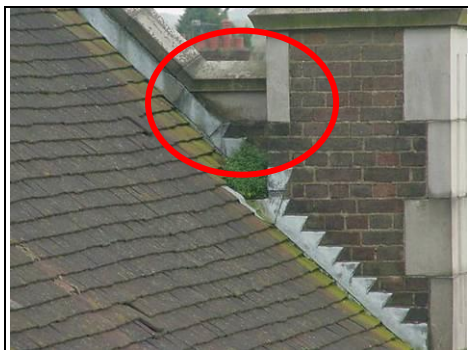
Awkward detail to parapet wall

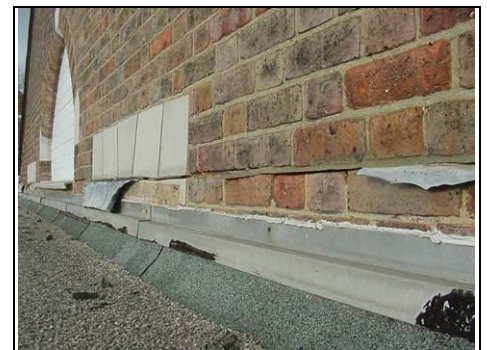
Flashing leaking into Unity Hall ceiling below where the 1970's extension meets the main building where it looks like the lead has been removed

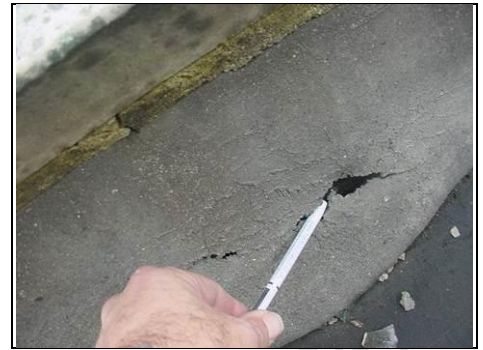
Deteriorating asphalt flashing to rear roof

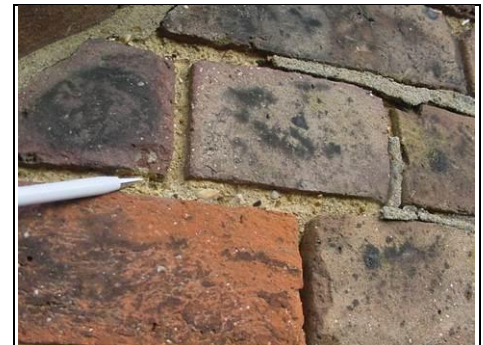
The original walls would have been pointed in lime mortar which help the property to 'breathe'. This has been incorrectly repointed with a harder cement mortar which prevents the property from breathing therefore causing dampness to the walls and spalling brickwork, which we can see and over the long term this will cause deterioration internally.

Cement mortar pointing, with lime behind it

We recommend a programme of works is carried out to repoint in an appropriate lime mortar which needs to be softer than the brick.

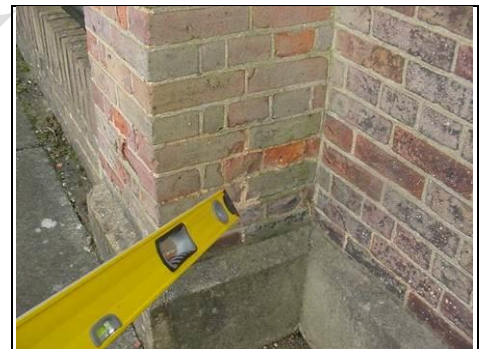
Damaged caused by repointing in cement mortar can be seen in the form of spalling brickwork.

This is where the face of the brick deteriorates due to the mortar being too hard around it and causing extra water to run over the brick which damages it from freeze/thaw action.

Spalling brickwork

ACTION REQUIRED: Find the oldest/most experienced bricklayer / stonemason to replace the cement mortar over time with lime mortar. At the same time replace any spalling bricks.

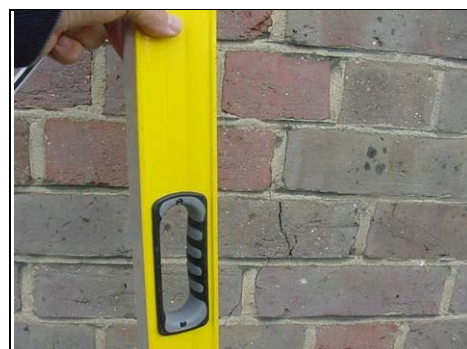
We would also draw to your attention that there looks to have been some minor movement to the rear right corner of the building. Please also read our comments with regard to the drains.

Cracking to brickwork

ACTION REQUIRED: This does look to be settlement but nevertheless we would always recommend the existing owners ideally take out an insurance claim, advising that the cracking has been noted by a structural surveyor (this should cost them nothing other than time to write the letter). This usually means that the insurance company will carry out a monitoring exercise (the Building Research Establishment recommend monitoring any cracks for a minimum of one year) to establish if there is any progressive movement.

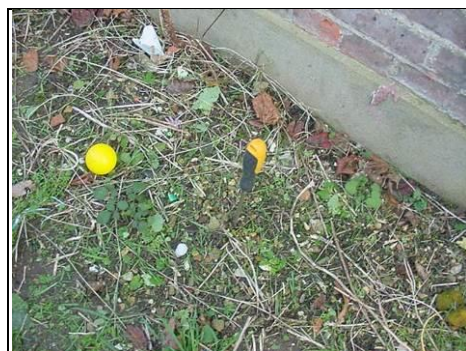
Very damp to rear of property

We feel the sloping site also adds to the dampness in the property as water is travelling down and around the sides of the property with no real travel route which we recommend is added, particularly as there is spalling brickwork.

1. To provide a proper drainage system running all the way around the property from the rear to the front, ideally adding a proper French drain.

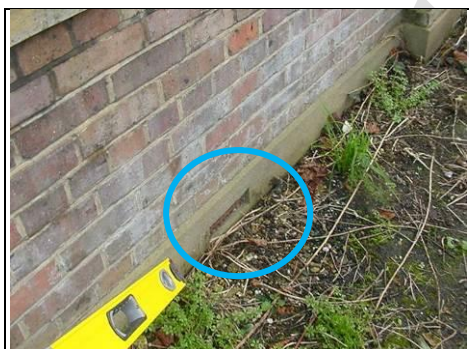
We can also see some air bricks in this area which means they are effectively acting as gutters and we fear there could be deterioration to the floor beneath the rear of the property.

Air bricks acting as gutters

ACTION REQUIRED: We recommend the floor is opened up before you legally commit to purchase the property to check its condition. We also recommend you stop the air bricks acting as gutters protecting them (see previous section).

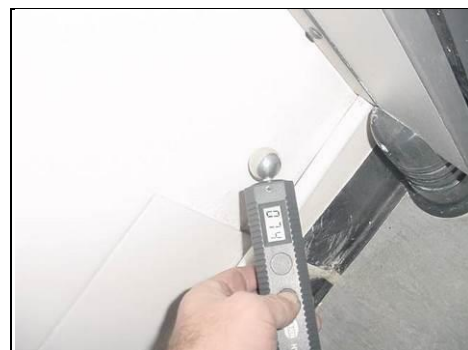
High damp readings in gents toilet to rear right corner

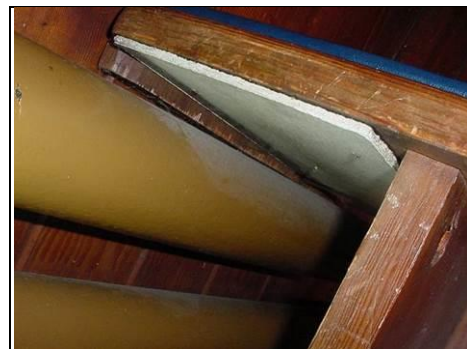
Asbestos under the seats next to the convection radiator?

You will need to use an independent asbestos contractor who does not have anything to gain from recommending asbestos removal.

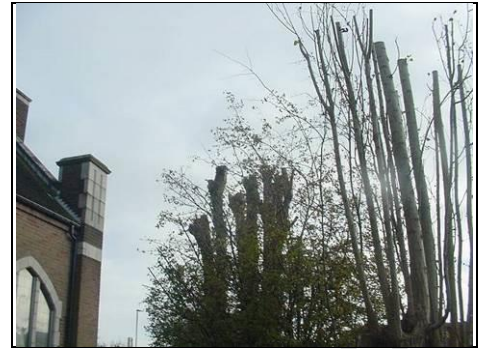
We found tree roots in the drains. The movement to the rear right corner could relate to the trees in this area, although interestingly there are more trees in other areas.

Pollarded trees

ACTION REQUIRED: We recommend an Arboriculturalist (not a tree surgeon) provides a 10 year plan on the tree maintenance and negotiation with the Local Authority regarding TPO's.

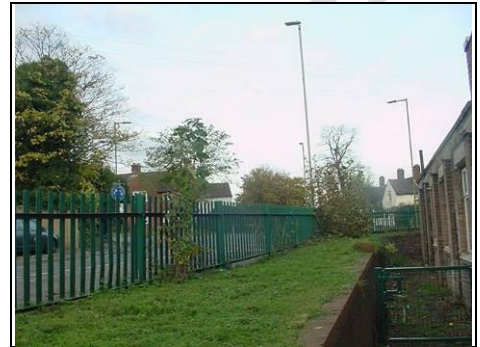
We lifted approximately four manhole covers, but there are around 6 or so manhole covers that we saw. We could see that water is sitting on the left side of the building. We would also refer you to our earlier comments about tree roots to the rear right corner which may also relate to the movement in this area.

ACTION REQUIRED: We would recommend a closed circuit TV camera report of the drains if one does not already exist.

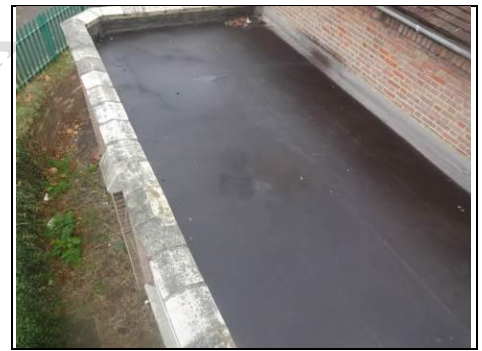
We noted that the flat asphalt covered roof has blistering and deterioration and some cracking to the flashing.

Blistering and deterioration to the flat asphalt covered roof

Whilst all these flat roofs could be kept going sometimes using a patch repair method, we do feel you will have to budget to start replacing them in the not too distant future. We would be happy to discuss this further with you if you so wish.

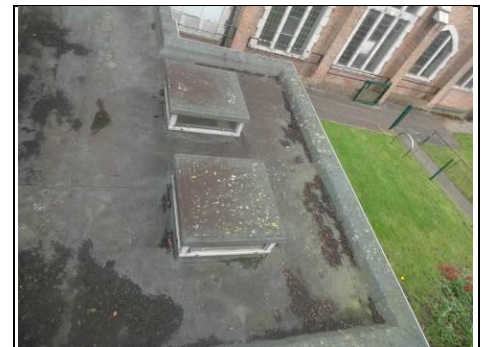
There is moss sitting on this roof and we noted a leak coming into the entrance lobby of the Unity Hall area below.

Rear left small flat roof

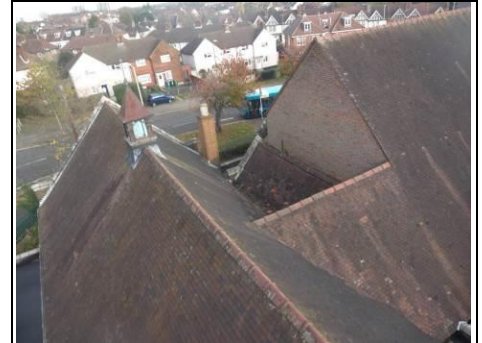
Main roof, with broken tiles on
valley gutter
Aerial view – 360 photo

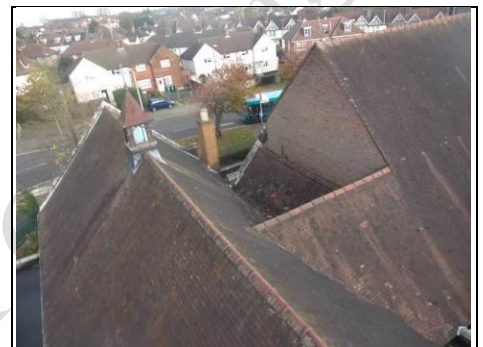
Hidden valley gutters to rear middle with broken slates sitting in this area
Aerial view – 360 photo

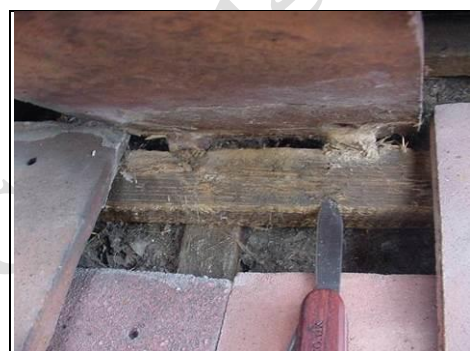
When we lifted the roof tiles space we found a Hessian base Bitumen membrane. This type of membrane has been used since the 1960s. We generally found it to be in average condition, it is damaged in a few more places than we normally find.

Hessian based underlay beneath roof tiles

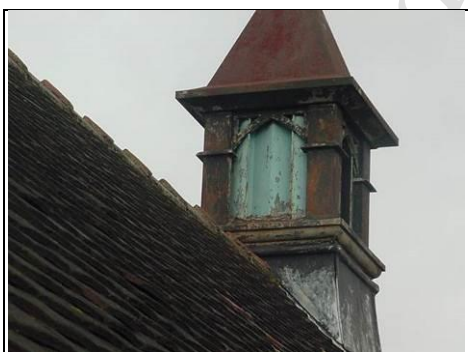
There are two towers on the main roof which appears to be vents, built in the style of a Belfry. We would comment they are starting to rust.

Vent/tower built in the shape of a church Belfry

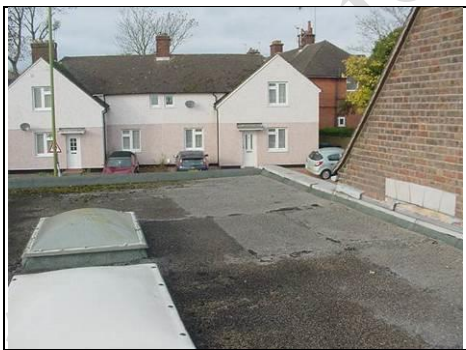
From ground level, these look in below average condition considering the roofs age type and style.

Rear left over Unity Hall
Aerial view – 360 photo

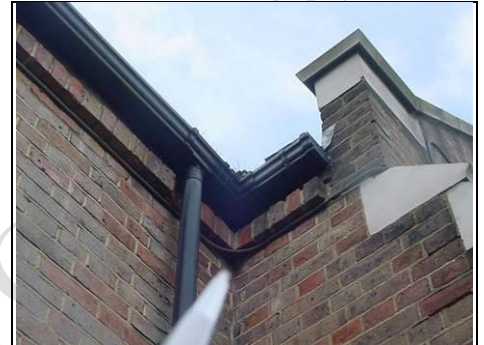
Dampness coming through from ogee gutters

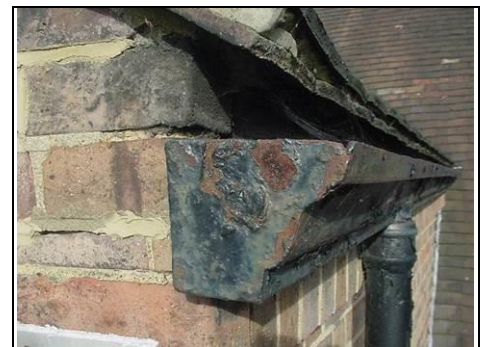
Rusting ogee gutters

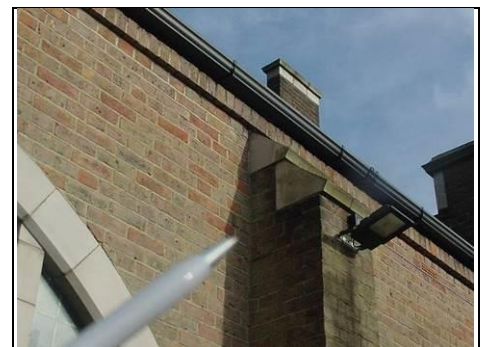
Sit on gutter with dampness coming through buttress below

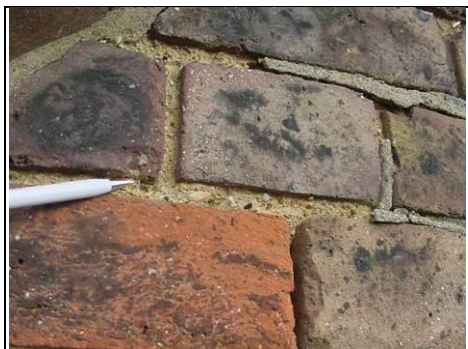
In this case the walls have been incorrectly repointed in cement mortar, preventing the property from 'breathing' and causing dampness and spalling brickwork.

Cement mortar coming away

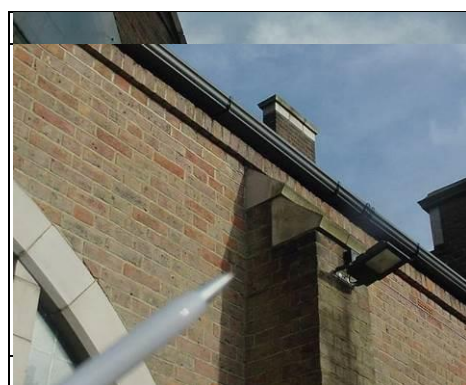
Dampness to buttresses coming from sit on gutter above

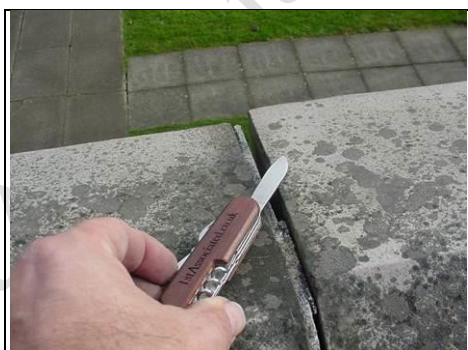
The capping stones on the parapet walls are weathered and there has been minor movement to some of them. We can also see there have been repairs in some areas.

Capping/copping stone has opened
up

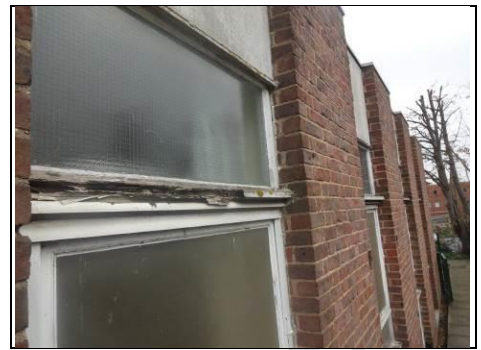
Deteriorating window

ACTION REQUIRED: Repair, prepare and redecorate and repoint window sills.

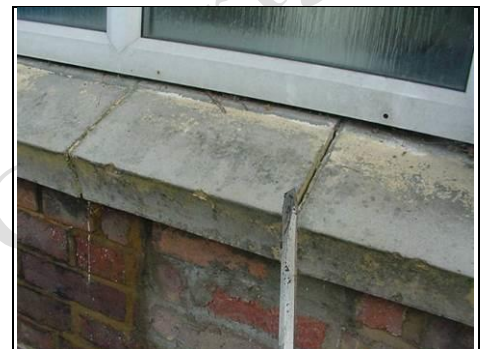
Window sills need repointing

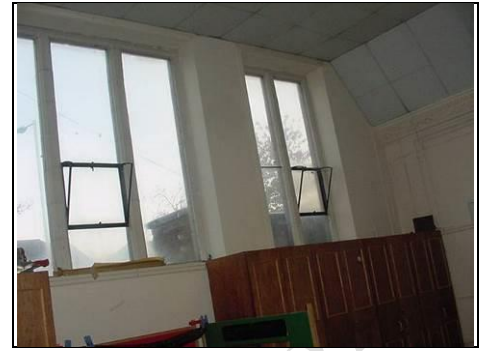
You may or may not be aware but from what we understand, the larger windows that have been covered with polycarbonate plastic to stop vandalism and damage are no longer openable.

Windows unopenable

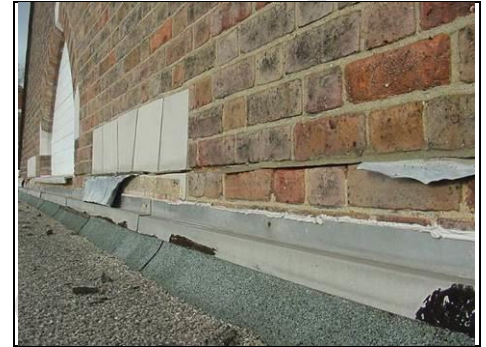
Leak in Unity Hall ceiling

Aluminium flashing has been added on roof above Unity Hall

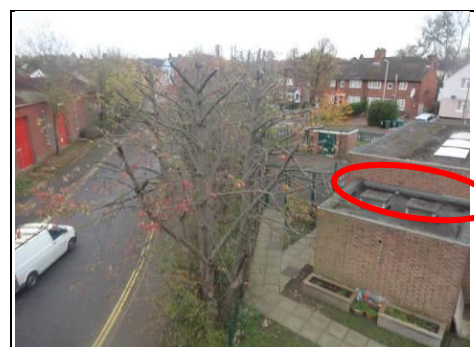
Dampness coming in to entrance to Unity Hall

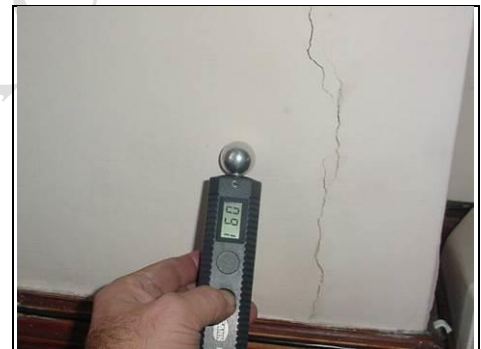
A visual inspection and tests with a moisture meter have been taken to the perimeter walls. In this particular case there were signs of dampness to some of the walls. It is always difficult with large older buildings such as this to assess the dampness on a room by room basis, however it is the side entrance to the property that we obtained readings approximately a third more than we would expect. Also undulations in the plaster are visible here.

High damp readings

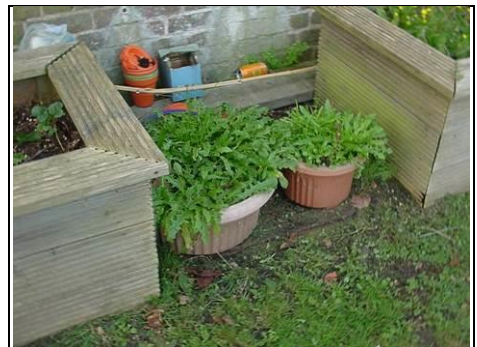
Front manhole close to Unity Hall we were unable to lift
