Church / Chapel Commercial Building Survey

Firstly, may we thank you for your instructions of xxx; we have now undertaken an independent Building Survey (formerly known as a Structural Survey) of the aforementioned property. This Survey was carried out on xxx.

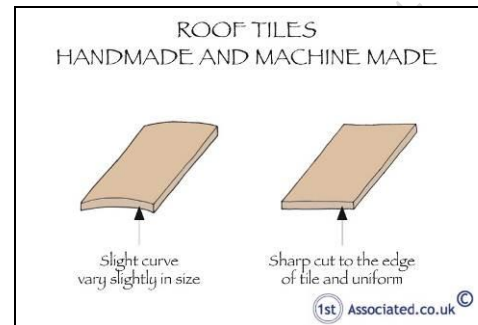
There is also a larger than average number of tiles that have slipped. We can also see that the original handmade tiles have been replaced with modern machine made tiles which never fit as well (see sketch).

Handmade and machine made roof tiles

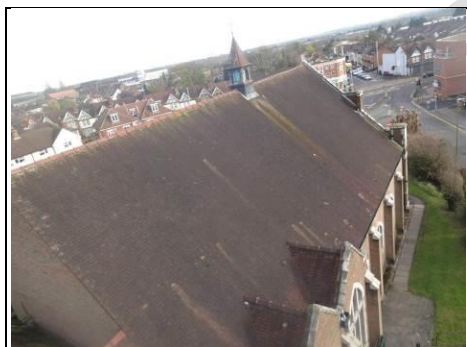
The main roofs are large, relatively steep pitched tiled roofs, with quite a number of tiles that are broken or been replaced with modern tiles.

Roof to left side of church
Aerial view – 360 photo

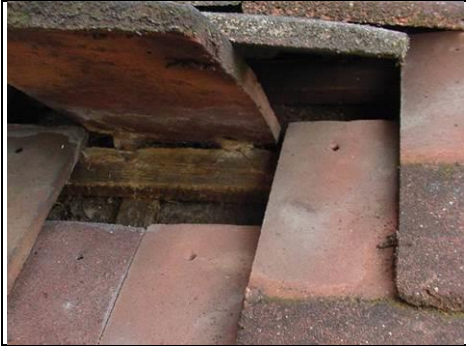
Our concern is beneath the tiles there are cross-battens, which in this case are deteriorating.

Lifting up roof tiles to find cross-battens beneath

To ensure the roof has a long life you will need at some time to remove all the tiles, clear the debris from the cross-battens and repair and replace tiles as necessary. It may be that this debris is only to the lower parts of the cross-batten areas.

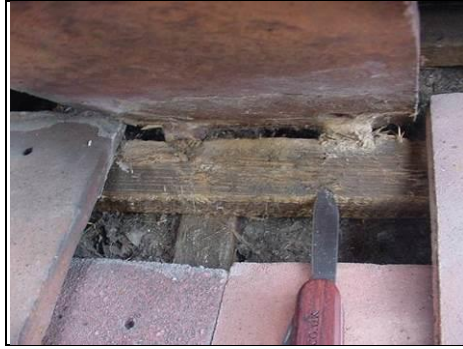
There is a substantial amount of debris beneath the tiles. From what we can see this is acting like blotting paper, causing the cross-battens to have accelerated rot and this needs clearing.

Soft rot occurring to cross-battens

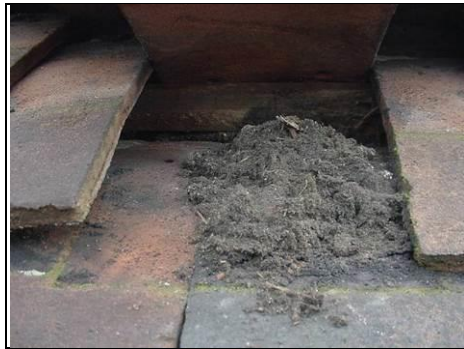
Lifting up rear tiles to find dirt and dust beneath

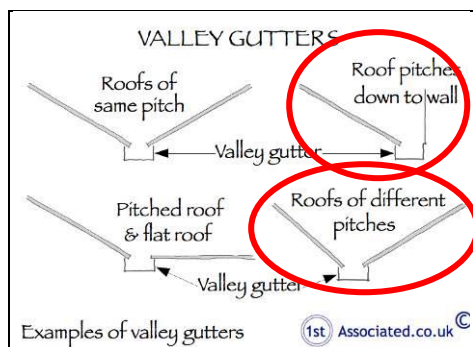
This roof has particularly awkward valley gutter areas.

Valley gutters

ACTION REQUIRED: We suggest investigation work and then work is carried out as soon as possible.

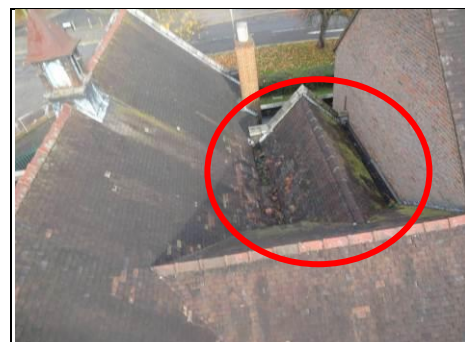
Roof over central office

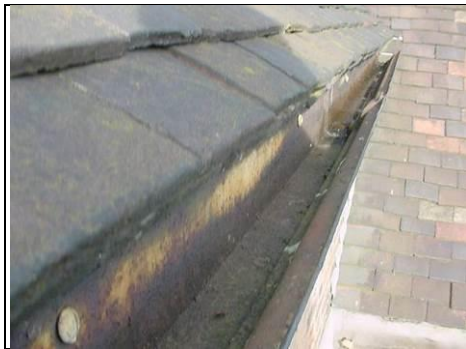
Ogee gutter

They are in cast iron and have not been maintained, which is particularly bad news with regard to ogee guttering as they tend to rust at the back.

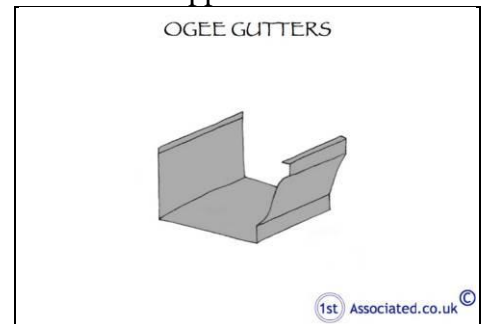
Ogee gutter

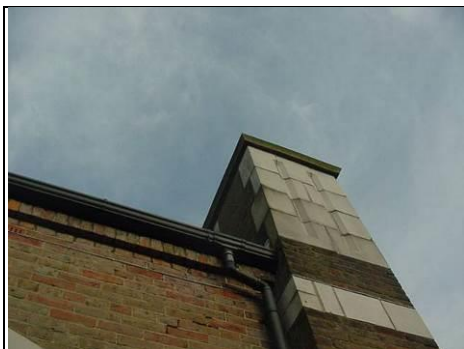
The second problem is the gutters are sit on gutters in many cases, meaning they sit on the walls, or partly on the walls, so that any leaks coming from them causes dampness to get into the wall structure and we can indeed see dampness getting in which we believe has caused the cornice to come away to the front right side of the main church area (it is likely to be other things such as blocked gutters from leaves etc). We were advised this happened about three years ago but we there is still high levels of dampness in this area.

Sit on gutters

ACTION REQUIRED: A high level inspection is required of the gutters to check they are sit on gutters. If they are sit on gutters then a programme of repairs and renewal of the gutters is recommended. It may even be necessary to put lead (or some sort of waterproof layer) underneath the sit on gutters depending upon how it is detailed.

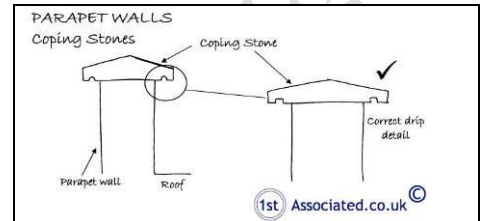
The ones that we could inspect were to the flat roofs to the rear which looked to be in reasonable condition, however some of them were starting to weather. We could see that there have been repairs to the coping stones and that joints are starting to weather, which is allowing water into the top of the walls. We noted in one area a metal capping had been placed over it so it is a known about problem.

Parapet walls and coping/capping stones

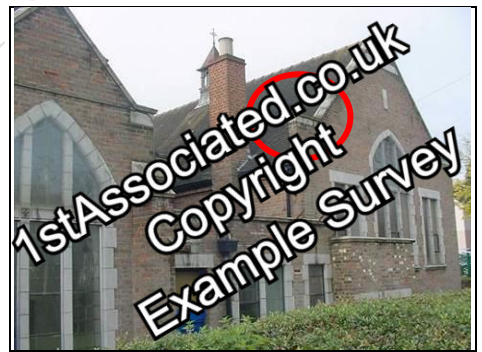
Cement coming out of rear parapet wall

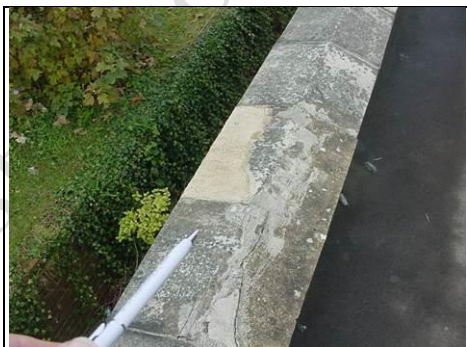
Repairs visible to coping stones

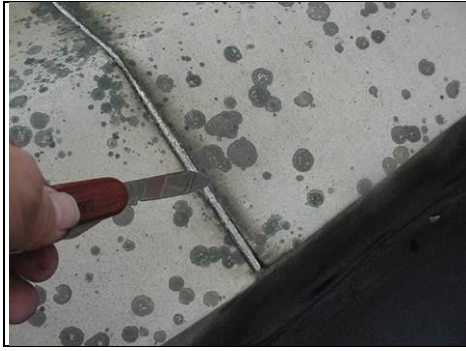
Weathered joints to coping stones

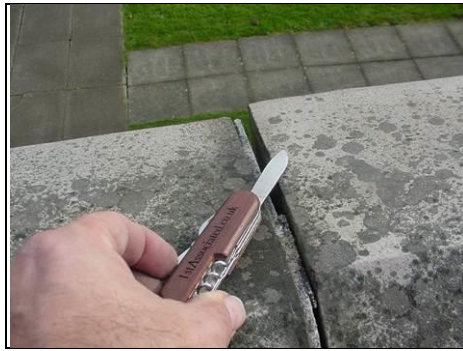
Joints opening up

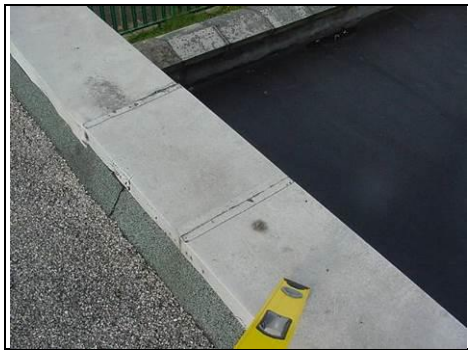
Capping to parapet wall to rear flat roof area

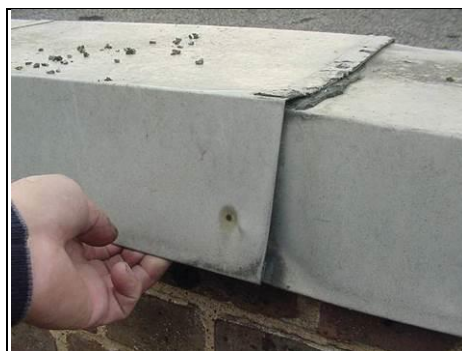
Capping has become unfixed

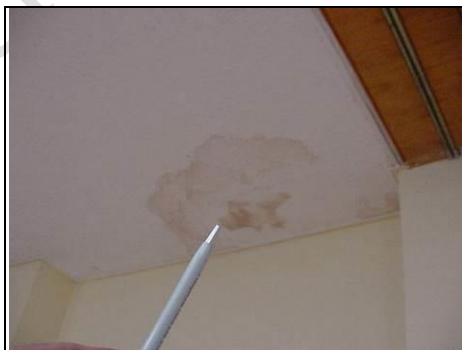
Probably the worst area we can see is to the rear of the property around the flat roofs, particularly on the rear elevation where water looks to have been getting in. We think this is coming in via the asphalt flashing which we can see has blistered and has a hole in it (see photo below).

Leak into Unity Hall ceiling from flashing leaking above

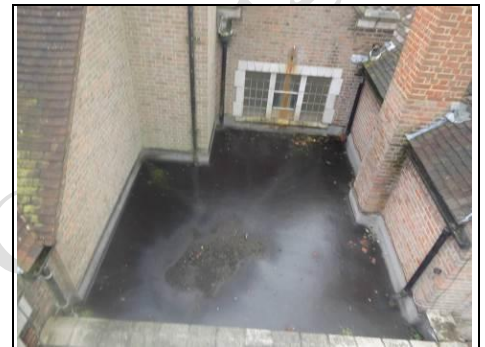
Flashings on rear roof with parapet wall in front

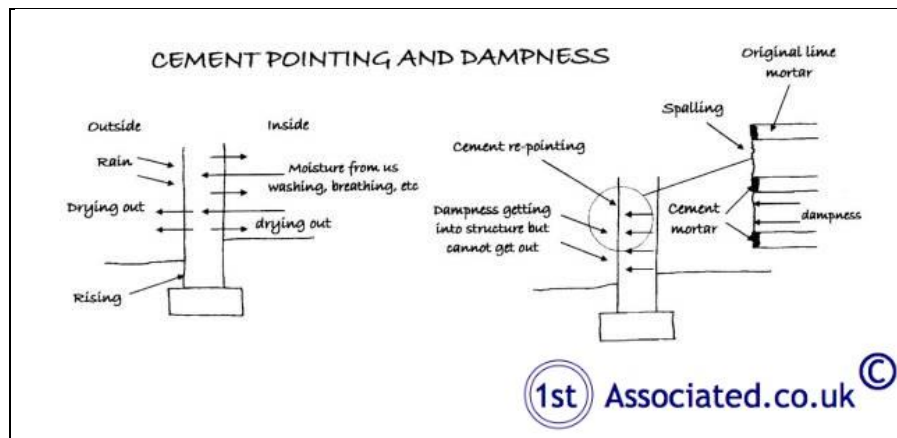
Use lime mortar every time on older properties

Damaged caused by repointing in cement mortar can be seen in the form of spalling brickwork.

ACTION REQUIRED: Find the oldest/most experienced bricklayer / stonemason to replace the cement mortar over time with lime mortar. At the same time replace any spalling bricks.

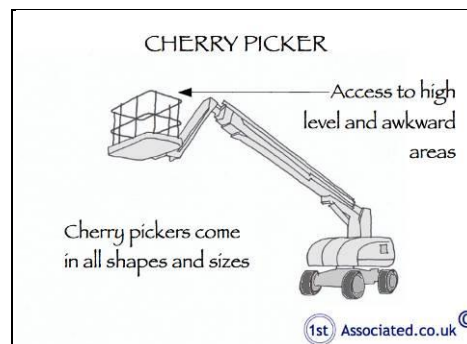
From what we could see there is no safe access for carrying out maintenance at high level which means it will be very difficult to access some areas.

Cherry picker

ACTION REQUIRED: Add what is generally known as a man-safe system to give access to high level areas.

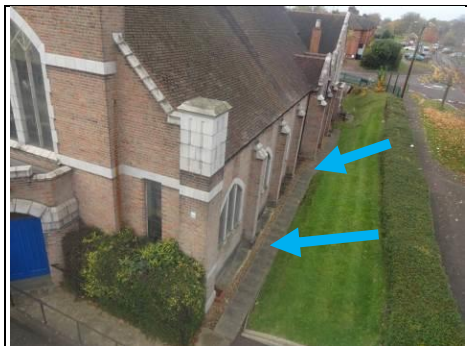
The property sits on a sloping site, meaning that water travels from the top of the site to the bottom. There is a retaining wall at the top and we were pleased to see weep holes, however this is discharging water against the rear of the building, leading to dampness in this area. A better system is required.

Sloping site discharging water towards church

1. To provide a proper drainage system running all the way around the property from the rear to the front, ideally adding a proper French drain.

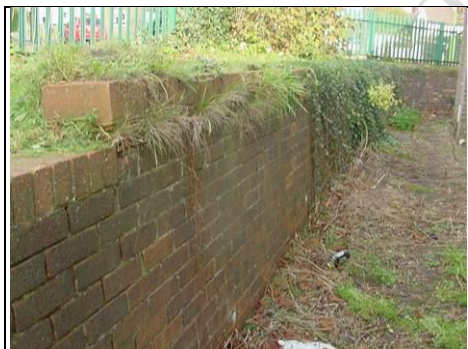
Rear retaining wall could do with more weep holes

2. Ensure the air bricks do not act as gutters.
3. The rear retaining wall needs some repointing work and also extra weep holes.

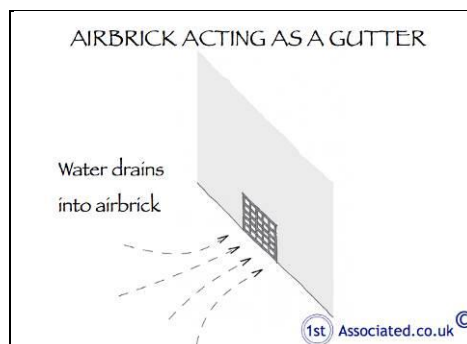
We can also see some air bricks in this area which means they are effectively acting as gutters and we fear there could be deterioration to the floor beneath the rear of the property.

Air bricks acting as gutters

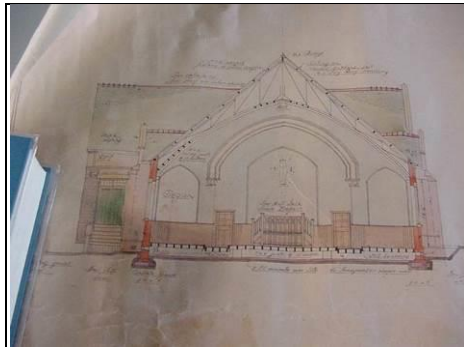
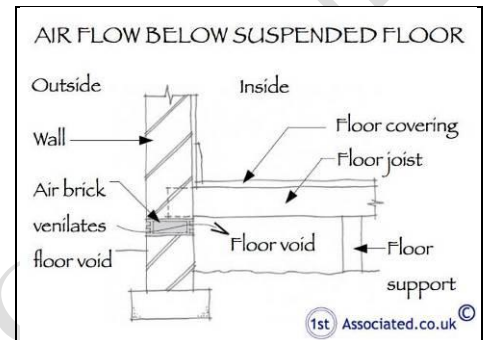
We were advised by the Warden that the floor was concrete with tar and timber on top of it. However, it does look from the air bricks and the old drawings that there may be a suspended timber floor. This is why we have recommended you open up the floor to check its condition, particularly to the rear of the property where most of the water is discharging onto it.

Suspended timber floor

ACTION REQUIRED: We recommend the floor is opened up before you legally commit to purchase the property to check its condition. We also recommend you stop the air bricks acting as gutters protecting them (see previous section).

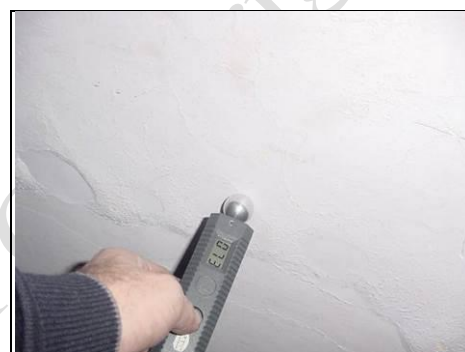
High damp readings in right reception room/chapel

The dampness should improve considerably when the property is repointed in a lime mortar and the water is re-directed around the building.

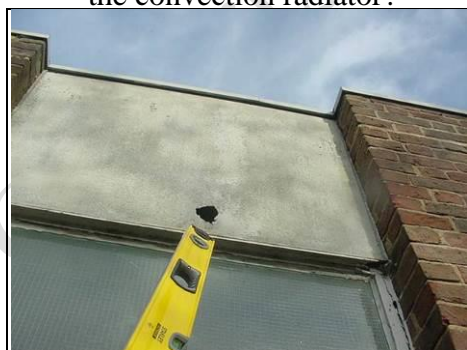
Fascia panels above windows on Unity Hall will need checking

We would look to replace the render panels on Unity Hall with a more thermally efficient cladding.

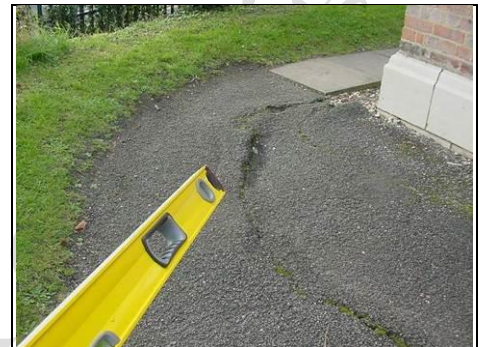
Tarmac lifting due to tree roots from nearby trees

ACTION REQUIRED: We recommend an Arboriculturalist (not a tree surgeon) provides a 10 year plan on the tree maintenance and negotiation with the Local Authority regarding TPO's.

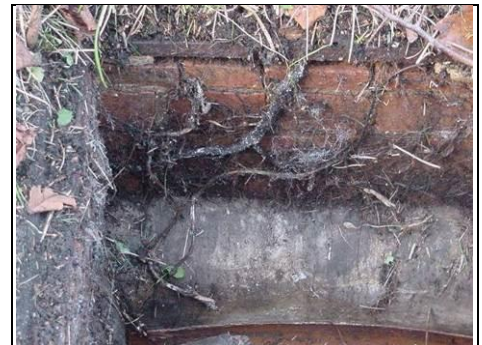
We found tree roots in the drains. The movement to the rear right corner could relate to the trees in this area, although interestingly there are more trees in other areas.

Tree roots in rear right manhole

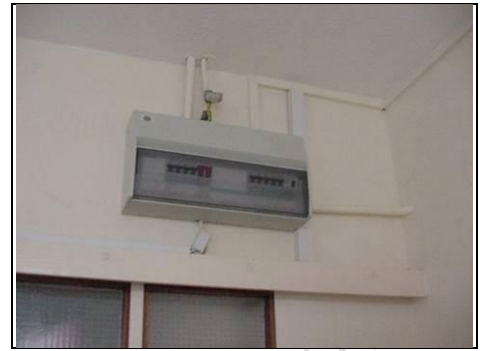
We were not given any records of when work has been carried out on the electrics. The units that we could see looked to be from the 1970's-1990's and are therefore dated and better are now available.

Fuse board in kitchen

ACTION REQUIRED: Check if the owners have Institution of Engineering and Technology (IET) test and reports by an NICEIC registered and approved electrical contractor or equivalent. If not then you need to have your own test and report carried out.

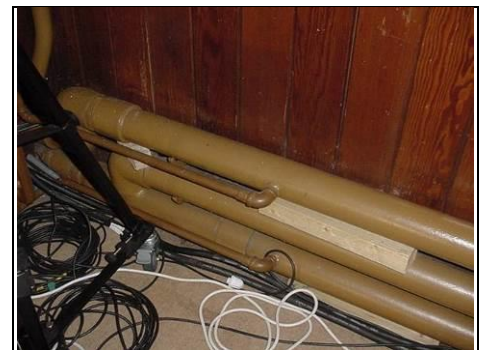
Convection radiator pipes

ACTION REQUIRED: We were advised that some precautions have been taken in relation to the sludge by blocking the new system. You need to find whether the system has been pressure jetted and cleaned and the exact details of what has been carried out with the heating system, because a new commercial boiler system can be very expensive.

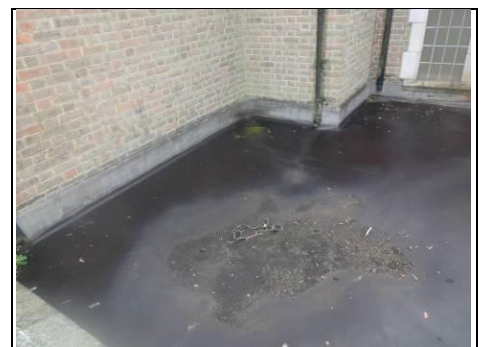
The middle right side roof, which we were not able to access however from the moss sitting on it we assume that the fall is not particularly good. Rainwater is also discharging from the relatively large pitched roofs close by and we feel work is likely to be necessary here.

Middle right roof with moss sitting on it due to it being a flat, flat roof with minimal fall

Whilst all these flat roofs could be kept going sometimes using a patch repair method, we do feel you will have to budget to start replacing them in the not too distant future. We would be happy to discuss this further with you if you so wish.

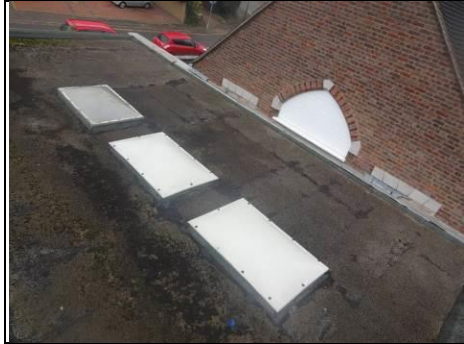
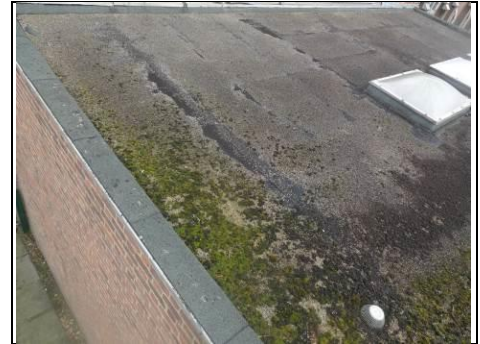
Moss is sitting on this roof indicating that water is not getting away properly. It looks like the parapet wall and flashings have had a problem which is why it has been felted over.

Rear left flat roof with moss covering

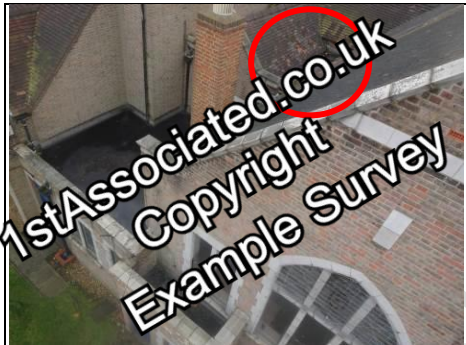
Middle right area with broken tiles (circled)

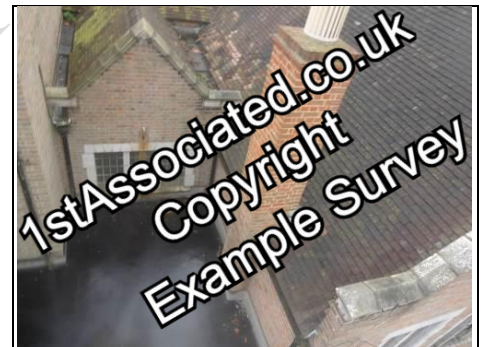
This chimney is brick finished with an asphalt flashing and one chimney pot. From what we could see from ground level the chimney and the flaunching looked in average condition considering its age, type and style.

Chimney to middle

ACTION	REQUIRED:	Periodic
inspection.

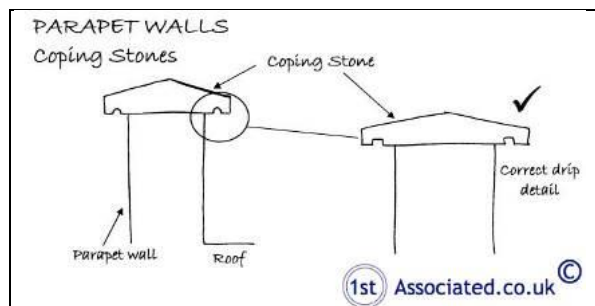
Parapet walls

We would advise that many of them are leaking and in need of repair.

ACTION REQUIRED: Please see our comments in the Executive Summary.

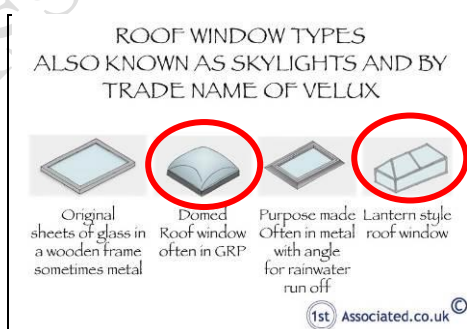
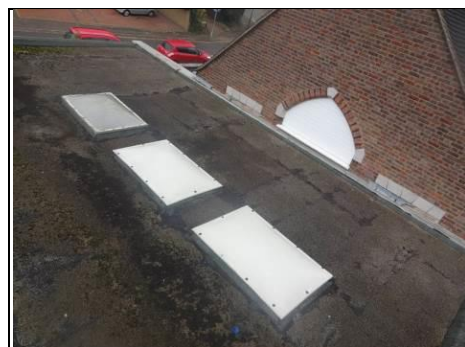
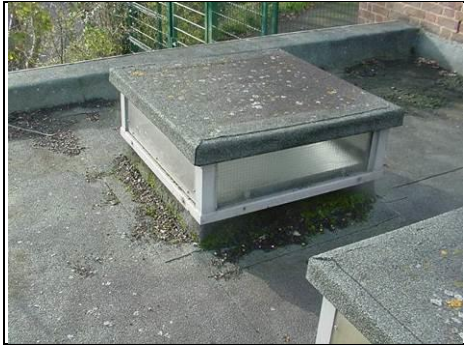
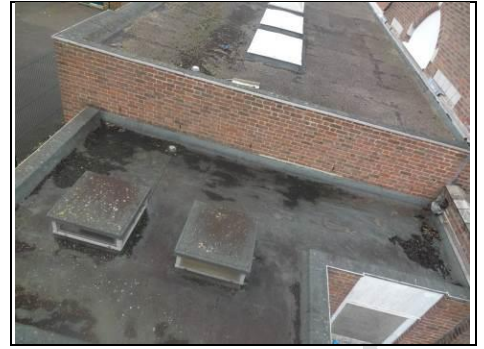
The rear left flat roofs has three domed roof windows on it, one of which looks to have been replaced. The lower rear roof has two lantern roof windows that look to be original. They look in average condition given their age, type and style.

Three domed roof windows to rear left roof
Aerial view – 360 photo

Lantern roof windows to lower rear
roof

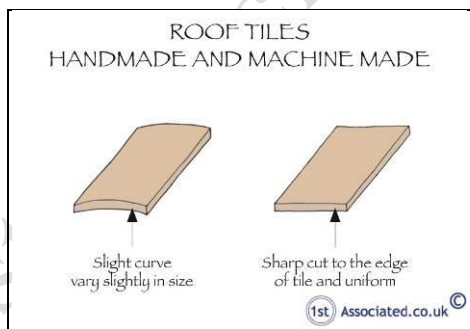
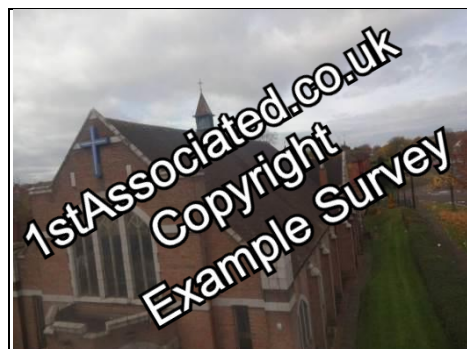
The roof is pitched and clad with a mixture of handmade and machine made clay tiles onto cross-battens. From ground level, this looks in below average condition considering the roofs age type and style.

Main pitched roof
Aerial view – 360 photo

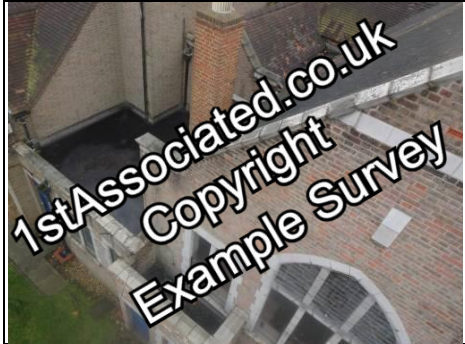
This roof is in probably the poorest condition of all the roofs. We were not able to access this roof and are not sure whether the roof is deteriorating or has been damaged by vandalism.

Middle hidden roof with tiles off
Aerial view – 360 photo

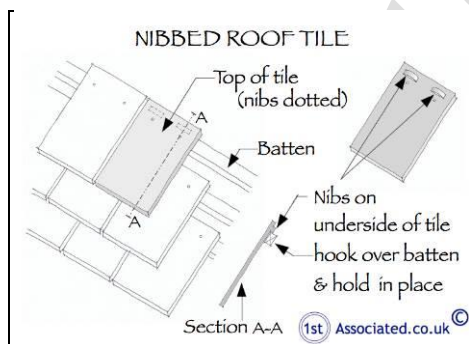
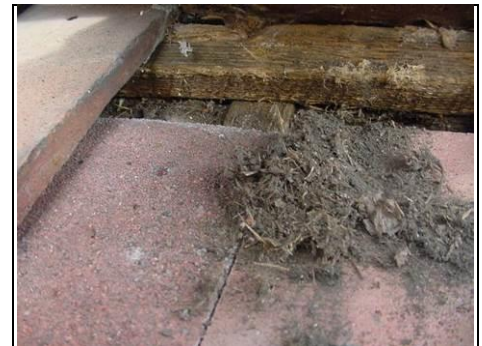
We lifted some of the roof tiles to reveal the cross-battens; there is a great deal of debris beneath the cross-battens. This tends to lead to the battens becoming damp and in turn the nibs of the tiles starting to deteriorate.

Dirt and timber

ACTION REQUIRED: Please see our comments in the Executive Summary.

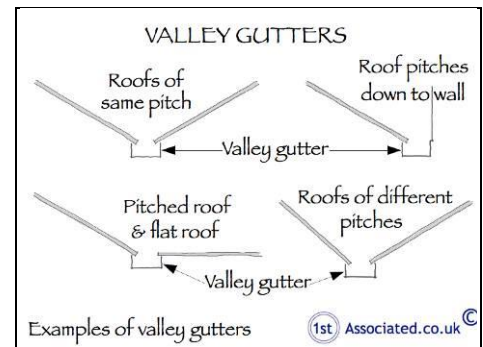
We would comment that valley gutters are often problematic areas as they are difficult to access to clear. In this instance with the surrounding trees we imagine they get blocked with leaves etc.

Valley gutters

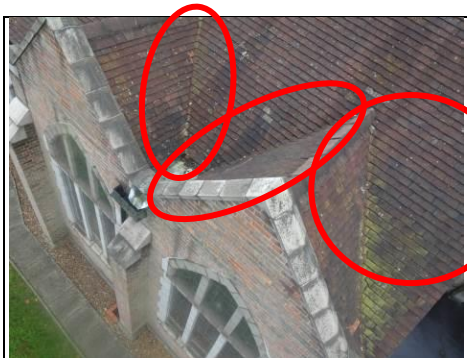
Valley gutter to left side of main roof
Aerial view – 360 photo

ACTION REQUIRED: You will need to keep the trees well maintained to reduce the amount of leaves and we also recommend a contract is put in place to clear the roofs and gutters periodically.

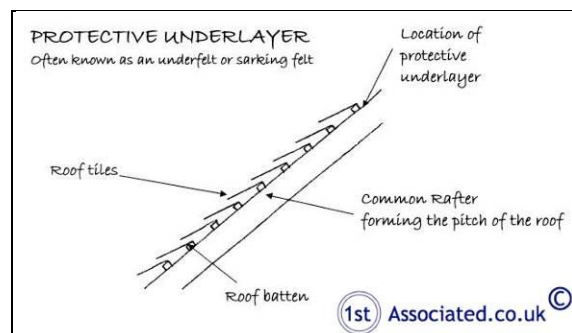
Protective underlayer

When we lifted the roof tiles space we found a Hessian base Bitumen membrane. This type of membrane has been used since the 1960s. We generally found it to be in average condition, it is damaged in a few more places than we normally find.

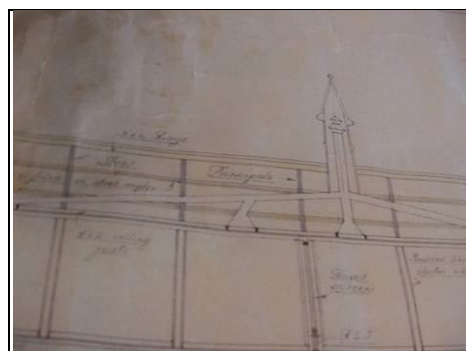
There are two towers on the main roof which appears to be vents, built in the style of a Belfry. We would comment they are starting to rust.

Plan showing venting system into tower

ACTION REQUIRED: Repair work necessary when high level work on the roofs is being carried out.

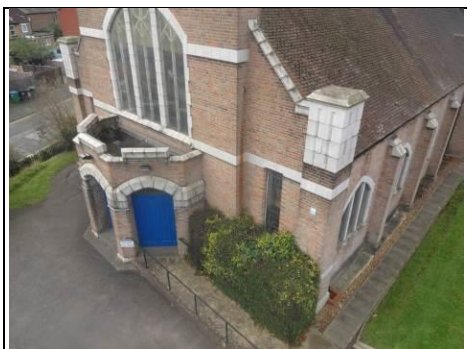
The roof is flat and is covered with asphalt. From ground level, this looks in average condition considering the roof's age type and style.

Right side flat roof
Aerial view – 360 photo

ACTION REQUIRED: Carry out periodic inspections and maintenance of the roof, as required.

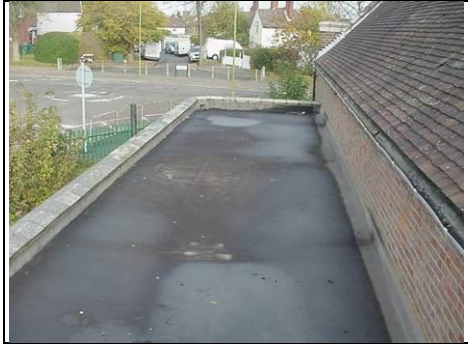
The roof is flat and is covered with asphalt. From ground level, this looks in below average condition considering the roof's age type and style. We can see problems with the flashing and blistering of the asphalt.

Rear single storey flat asphalt roof

ACTION REQUIRED: Please see our comments in the Executive Summary.

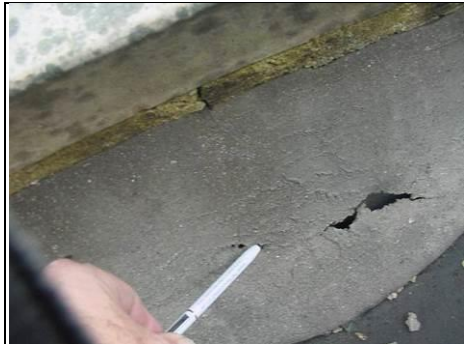
Close up of blistering

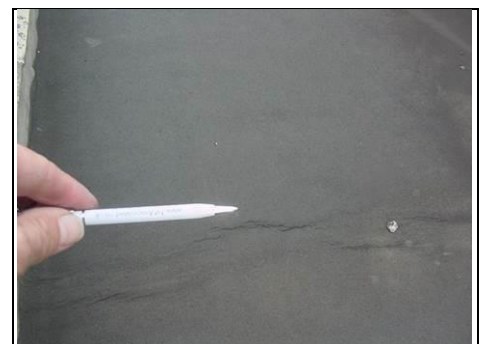
Splits starting to appear

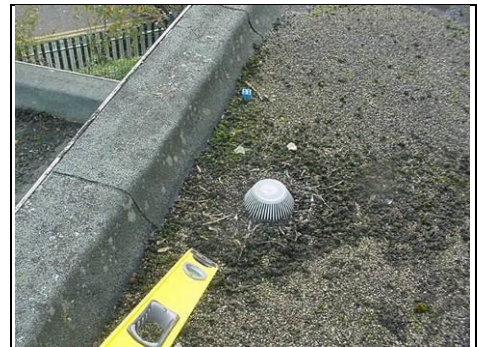
Internal downpipe on roof

The downpipes on this roof are internal. Internal downpipes do tend to be problematic, particularly when they leak.

ACTION REQUIRED: General upgrading of the roof required.

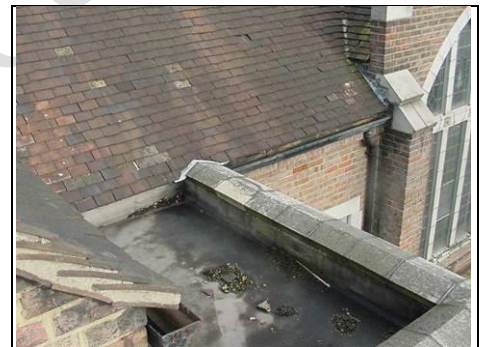
Internal downpipe on roof

General upgrading of the flat roofs is required, although they can be patch repaired for some time.

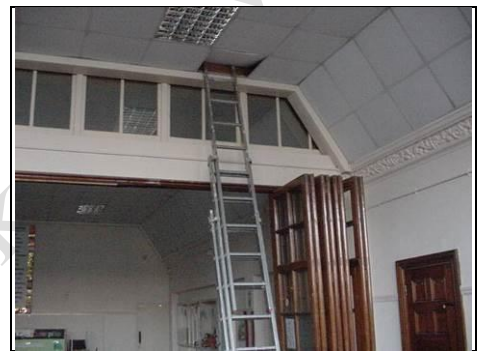
Suspended ceiling tiles
in School Hall

ACTION REQUIRED: We recommend that the roof is inspected and that access is provided to enable us to safely access the roof space.

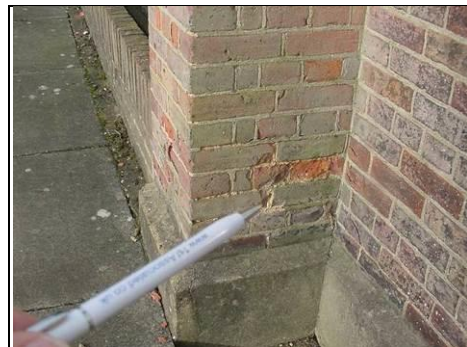
In this case the walls have been incorrectly repointed in cement mortar, preventing the property from 'breathing' and causing dampness and spalling brickwork.

Spalling brickwork

ACTION REQUIRED: Repoint in a lime mortar and repair/replace spalling bricks.

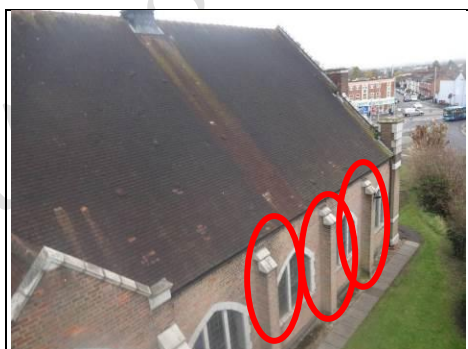
There are buttresses either side of the windows with a stone capping. They are relatively slender considering the window size and as such we feel may be working in conjunction with the steel framework, which we have not been able to see.

Buttresses to right side.
Also note slipped tiles

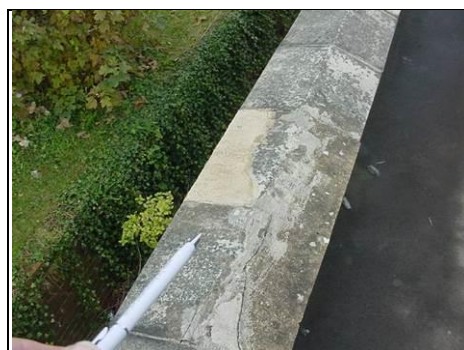
The capping stones on the parapet walls are weathered and there has been minor movement to some of them. We can also see there have been repairs in some areas.

Cracked capping stone that has
been repaired

ACTION REQUIRED: These do need a programme of work to ensure they are watertight.

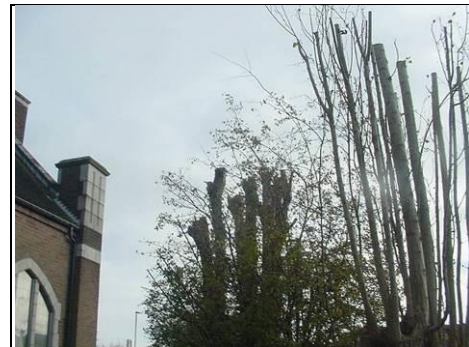
At the time of our survey we were advised that the trees had been recently pollarded. Regular maintenance will need to be carried out on the trees or they can cause all kinds of problems to the building.

Trees close to property, which have been pollarded

ACTION REQUIRED: We would recommend an arboriculturalist (not a tree surgeon) is asked to view the property and give a ten year plan for maintenance of the trees.

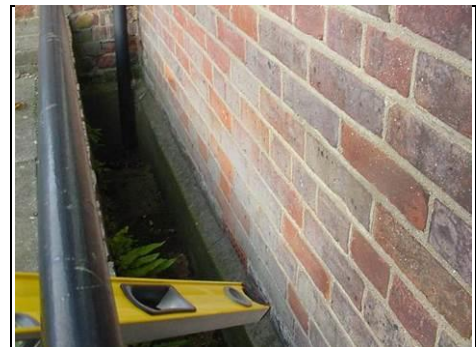
The ramp access to the left side has caused a box gutter situation.

We believe water will build up/back up here.

Box gutter

ACTION REQUIRED: It is essential to ensure that this area is regularly cleared of leaves etc, otherwise you will get a considerable amount of dampness in the property.

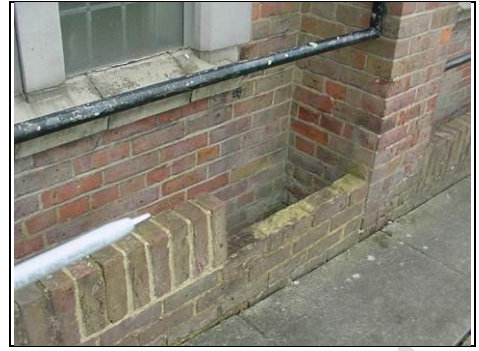
Box gully to left side needs some brickwork rebuilding, as well as keeping it clear of leaves, etc.

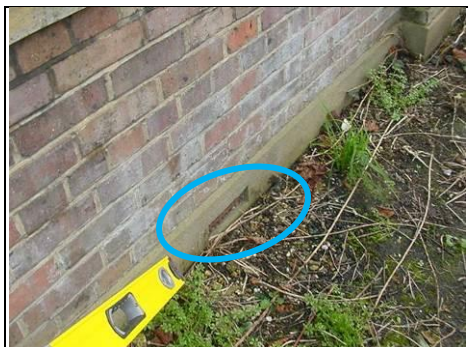
To the rear of the property we do believe there is a suspended floor. Air bricks are essential to have a through flow of air as this helps to reduce the chances of wet rot, dry rot and woodworm. Unfortunately the rear section is near the retaining wall which is on a sloping site and as such we feel water will run in this area and allow dampness under the floor. The air bricks are quite low and are acting as gutters.

Air brick to rear acting as gutters

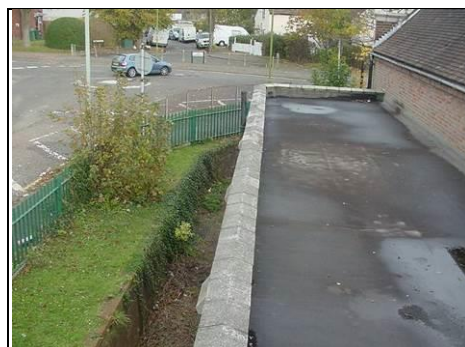
Rear retaining wall on a sloping site

ACTION REQUIRED: Ensure the airbricks are clear and protected and the whole area to the rear needs to be kept clear, with some repointing work needed to the rear retaining wall.

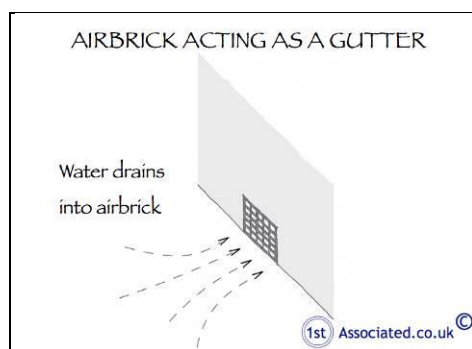
Air brick acting as a gutter

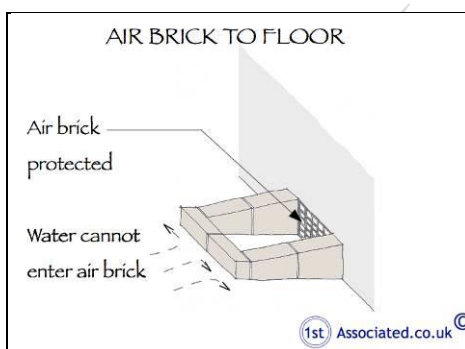
Protected airbrick

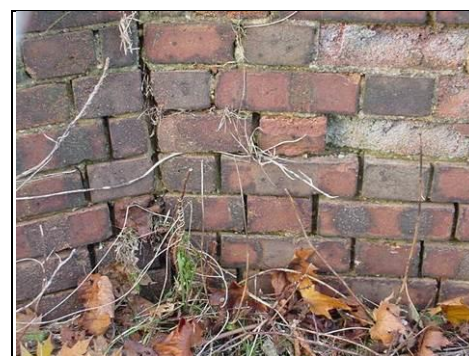
Retaining wall needs repointing

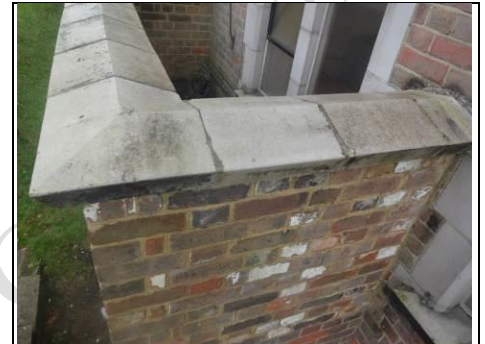
Enlarged parapet wall on right side of property

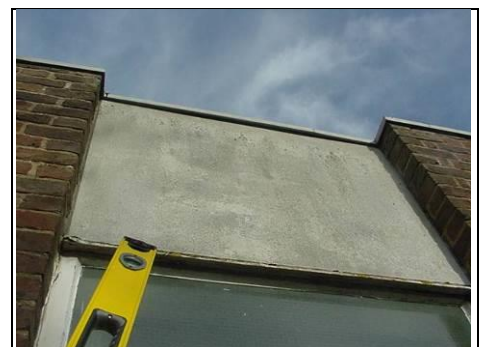
Fascia panel needs checking

ACTION REQUIRED: We recommend this is tested for asbestos, if this has not already been tested. It also needs repair and redecoration and one of them has a hole in it.

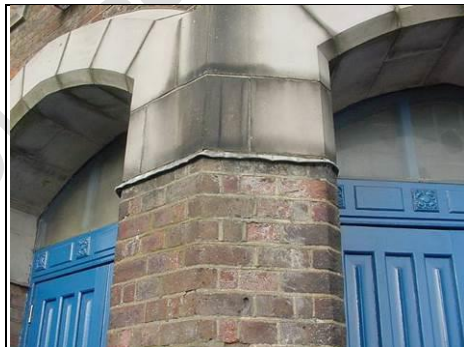
There are stone mullions and transoms surrounding the windows which are in average condition for their age, type and style. You will at some point need to carry out repointing and possibly cleaning and if you look closely at the windows you can see the metal angles that hold the polycarbonate sheets covering the windows in place.

Stonework needs cleaning

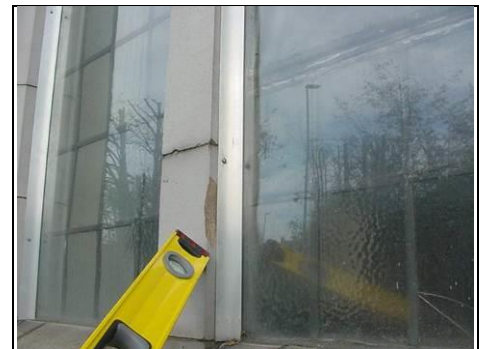
Metal angle holding the
polycarbonate sheeting in place

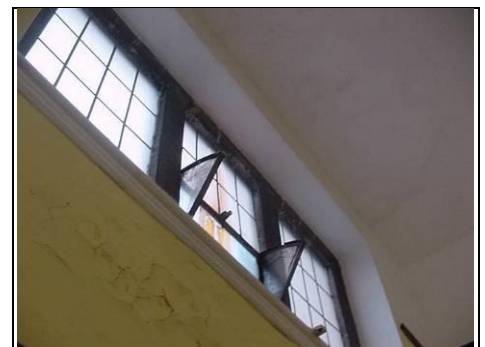
High level window where dampness is coming through into the Central Office

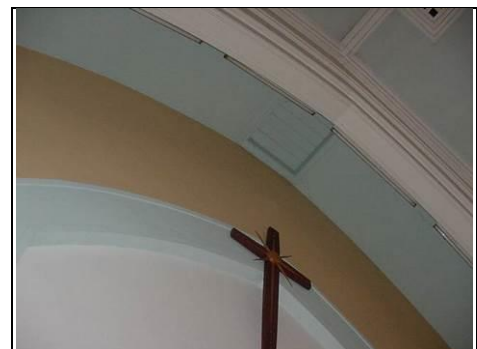
There is an access hatch for the roof above the pulpit in the church which we were unable to access due to its height. There were signs of water coming in; please see the roof and gutters section of this report.

Loft hatch in church which we were unable to access

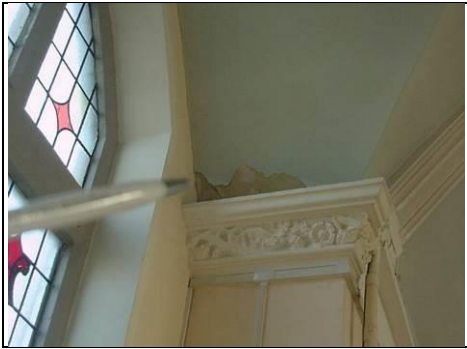
Signs of water coming in

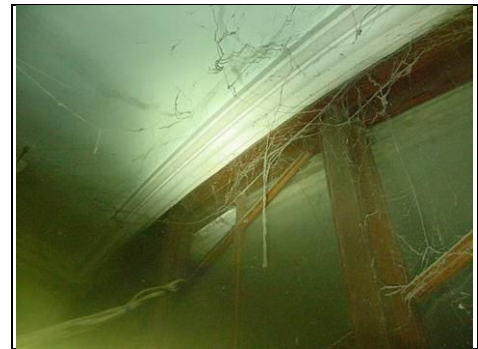
Old panelled ceiling covered in cobwebs

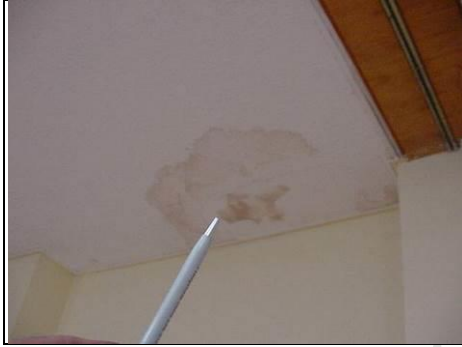
This has a flat roof over it. We noted a leak in this ceiling. There are number of roof windows to the ceiling which are susceptible areas for dampness, however the leak seems to be at the junction with the main building where the lead flashing has been removed and an aluminium flashing added. This in turn then looks to have had bitumen repairs.

Leak in Unity Hall ceiling

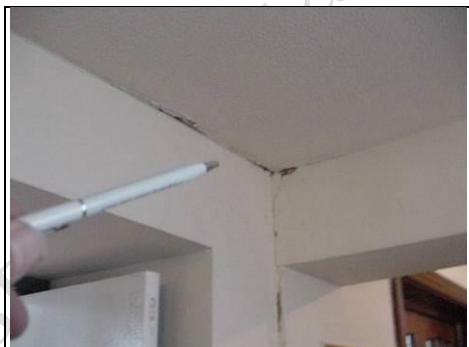
These look to have a mixture of lath and plaster ceilings and modern ceilings, all in reasonable condition for their age, type and style, although there is some dampness getting into the entrance to the Unity Hall area. This is where the flat roofs meet at roof level.

Dampness coming in to entrance to Unity Hall

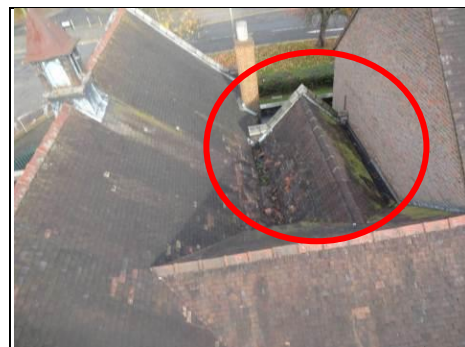
Leaks are likely from the hidden pitched roof over the central office which is in poor condition and we feel it is only a matter of time before water gets in this area with the awkward valley gutters and deterioration to the roof.

Roof over the central office
Aerial view – 360 photo

ACTION REQUIRED: Work needs to be carried out on this part of the roof to avoid damage and deterioration to the office.

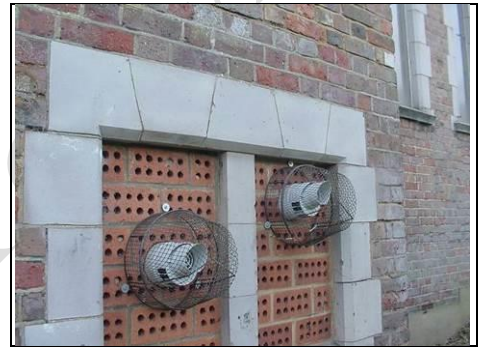
Chimneys are often re-used today as flues. From what we could see though the boiler house is now flued via what was once a window on the right side of the property.

Flues from boiler house through an old window

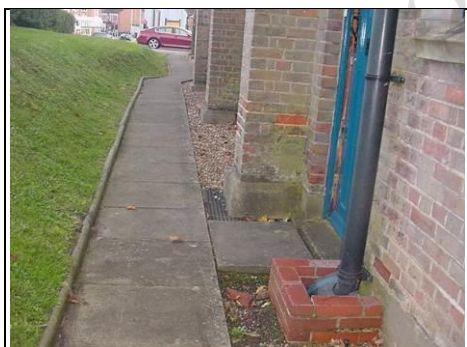
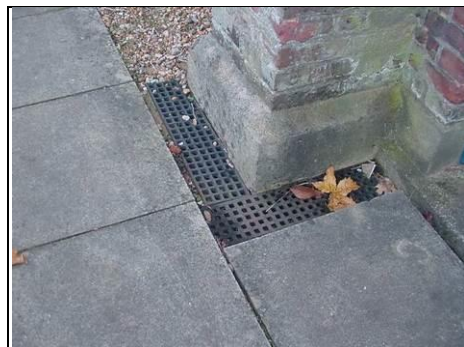
There is a gully in this area so there may be some drainage problems and the water may discharge towards this area.

Gully

Close up of gully

Without major work to the property, such as adding a proper French drain around it and managing the water movement around the property there will to some extent always be dampness.

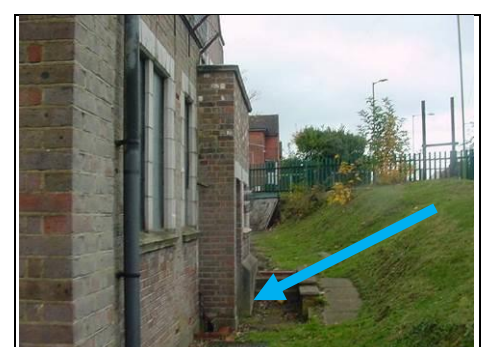
Water may discharge towards building due to sloping site

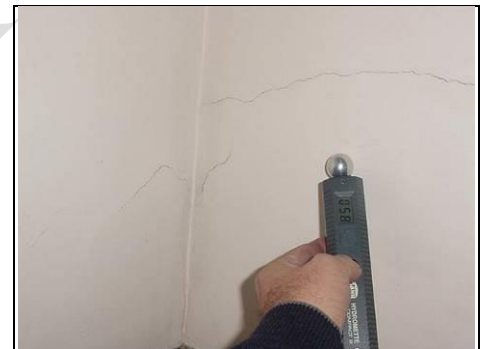
We used a resistance meter on the external walls. We found it to be in line with what we would expect for this age, type and style of property.

Testing for lateral dampness

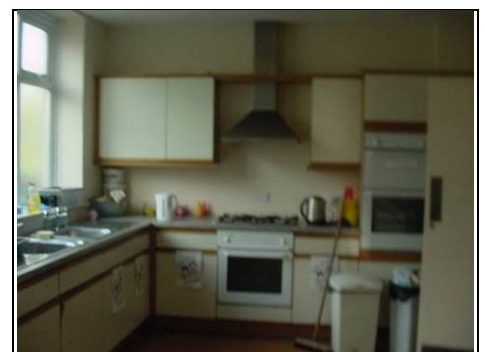
We found the kitchen in average condition/slightly dated and would comment it has domestic quality equipment. We recommend redecoration. We have not tested any of the kitchen appliances.

We also noted there was a water heater giving hot water which needs to be regularly serviced.

Kitchen

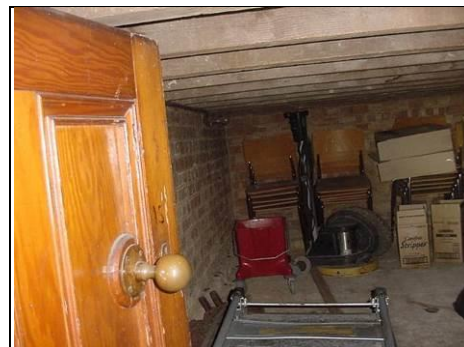
The roof /floor is the main area that we look for woodworm. Within the floor we found no obvious visual signs of significant woodworm activity or indeed past signs of significant woodworm activity that has caused what we would term 'structurally significant' damage. In many properties there is an element of woodworm that is not active. Our inspection is usually restricted by the limited area of the timber floor we could see, which was the area behind the organ and under the floor of the central office (approximately 10% of the area). We were unable to view the roof structure at all.

View under central office floor

ACTION REQUIRED: Again we would be more than happy to return if better access is made available.

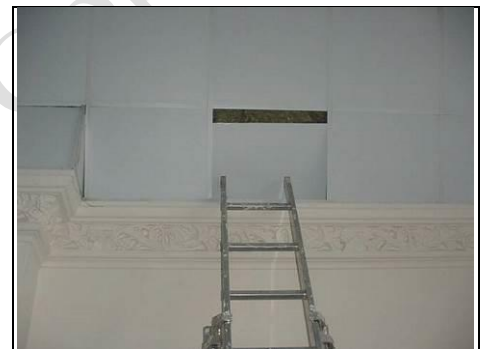
It is difficult to say if it has insulation or not. The 1970's was the Era when we first started considering insulation.

Suspended ceiling tiles in crèche with insulation behind

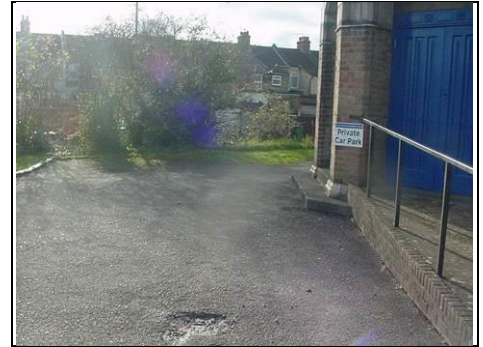
There is parking to the front of the property and there is a private car parking sign in this area. There is some wear to the surface.

Parking area to the front

ACTION REQUIRED: Make good the pot holes.

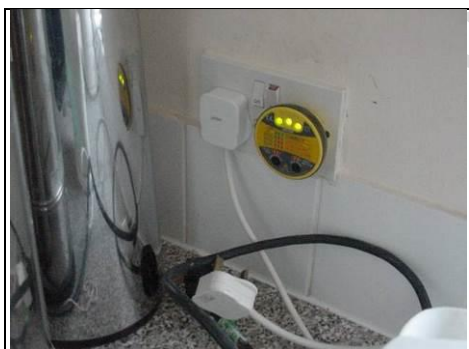
Earth test in kitchen proved satisfactory

ACTION REQUIRED: The existing owners to provide an Institution of Engineering and Technology (IET) test certificate, carried out by an NICEIC registered or approved contractor or equivalent standard.

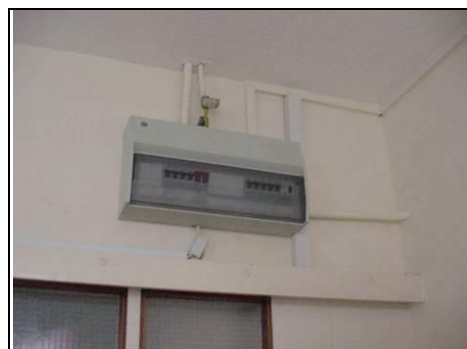
There are various fuse boards throughout the property. We were unable to establish how the property is divided electrically. We would recommend that regular testing of the electrics is carried out.

Fuse board in kitchen

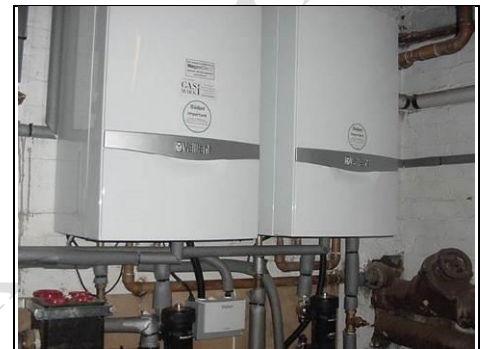
Vaillant Boilers

The property has two wall mounted Vaillant boilers that we are advised are relatively new.

We normally see commercial boilers within large buildings such as this and it does seem a particularly large area for two domestic style boilers to be heating. We spoke to the Warden about this and he advised they had had calculations, often referred to as British Thermal Units carried out.

ACTION REQUIRED: We recommend your legal adviser asks for copies of these and ensure that the building can be suitably heated. New boilers for a building such as this can be costly.

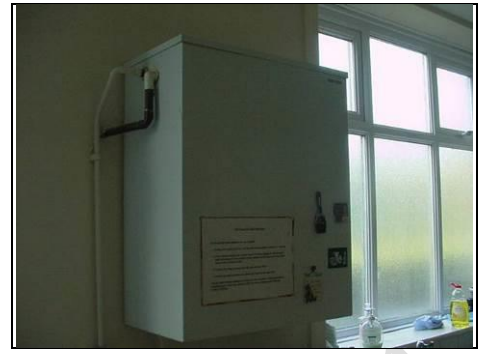
Hot water heater

There is a hot water heater located in the kitchen. This needs to be regularly tested.

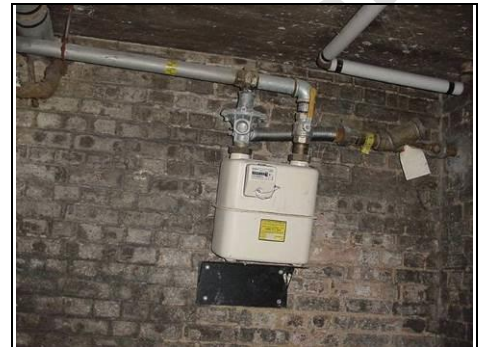
Gas unit

The gas consumer unit is in the basement plant room. The respective safety standards to be applied and obtain a test certificate. All services to Gas Safe Standard or equivalent.

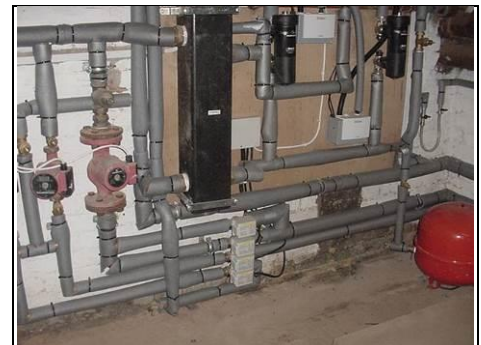
It is very difficult to see any plumbing, with the exception of the plumbing in the basement plant room which looked relatively new.

We would just query whether the basement is susceptible to flooding.

Plumbing in plant room

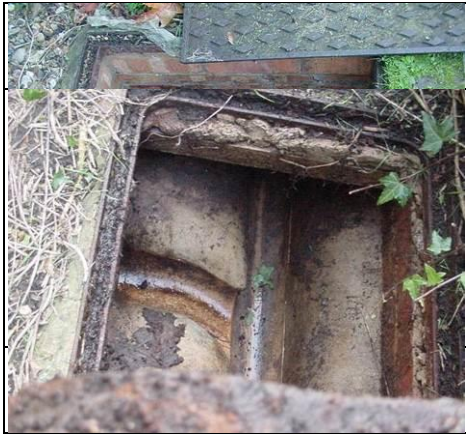
Middle rear manhole clear at time of survey

ACTION REQUIRED: We would recommend that a closed circuit TV camera report is carried out.

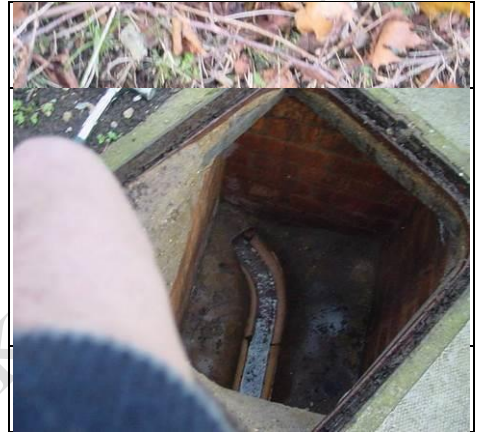
The manhole to the left corner is close to the Unity Hall and had water sitting in it, indicating there may be a lack of fall to the drain.

Left corner manhole close to crèche, clear at time of survey

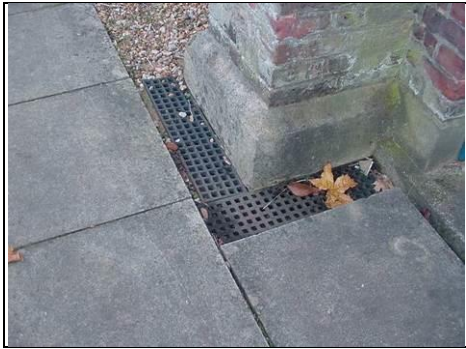
Drain located to middle right

It would appear that water does discharge against the building to the rear and sides. This does lead us to ask the question does the basement area flood?

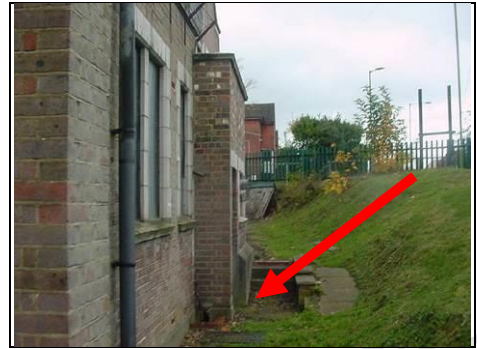
Sloping site tipping water towards building
